**Flood Control Project Maintenance
Levee Inspections**

Fall 2018 Levee Maintenance Deficiency Summary Report

San Joaquin River Basin

Reclamation District No. 0001 Union Island

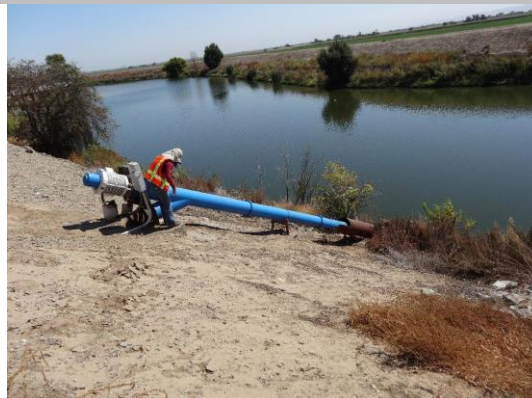
Photo 1 of 3 : UCIP_FA_2018_52628_36036.jpg

| UCIP Comments: - Pipe has leaks on WS that may cause erosion to slope.- 2" electric conduit on WS.- power pole on LS | | | | | | |

WS view: steel pipe and slant pump on levee slope. Pump on concrete pad.

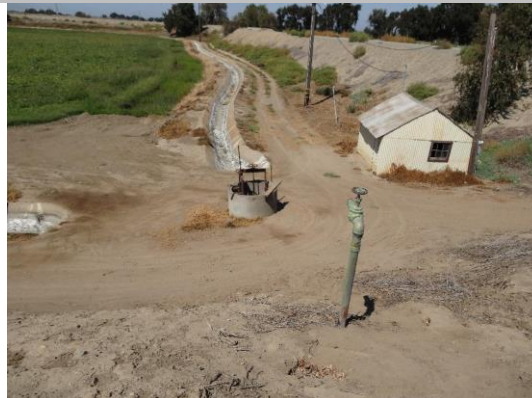
Photo 2 of 3 : UCIP_FA_2018_52628_36034.jpg

LS view: air relief valve on levee slope and concrete distribution box on levee toe.

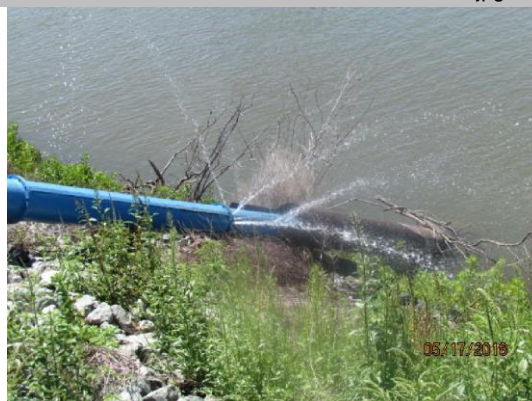
Photo 3 of 3 : UCIP_FA_2018_52628_77561.jpg

| UCIP Comments: - Pipe has leaks on WS that may cause erosion to slope.- 2" electric conduit on WS.- power pole on LS | | | | | | |

WS view: leaking irrigation pipe may cause damage to WS slope.

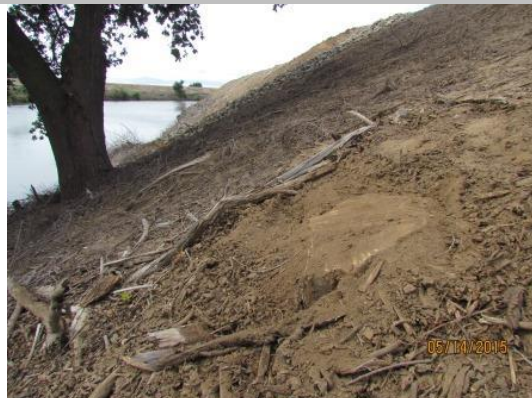
Photo 1 of 1 : FA_2018_RD0001_23_12_20180906_00010.jpg

| T5 : Tree stumps. | | | | | |

View of the tree stump on the waterside levee slope.

| Remove stump when it becomes rotted to prevent possible seepage path along the roots. | | | | | |

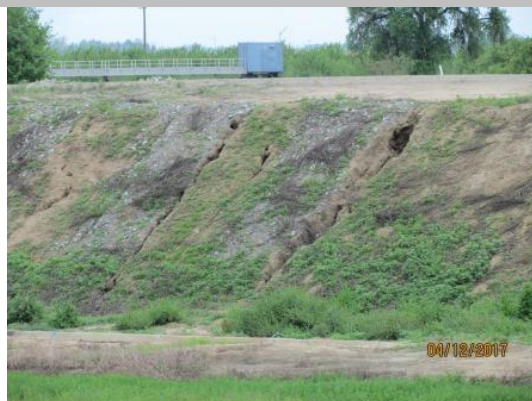
Photo 1 of 1 : FA_2018_RD0001_23_18_20180906_00015.jpg

View of the erosion on the levee slope.

| E2 : Schedule repair of erosion site prior to the next inspection. | | | | | |

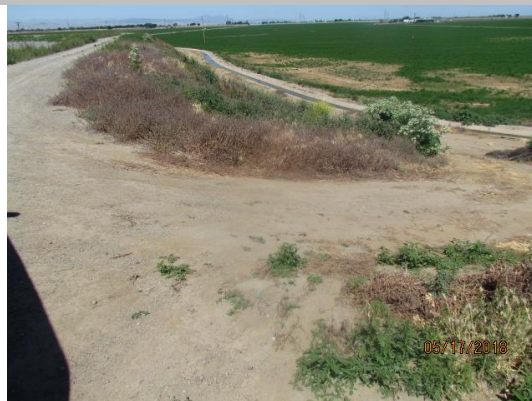
Photo 1 of 2 : FA_2018_RD0001_23_17_20180906_00013.jpg

| Unauthorized ramp on landward slope. | | | | | |

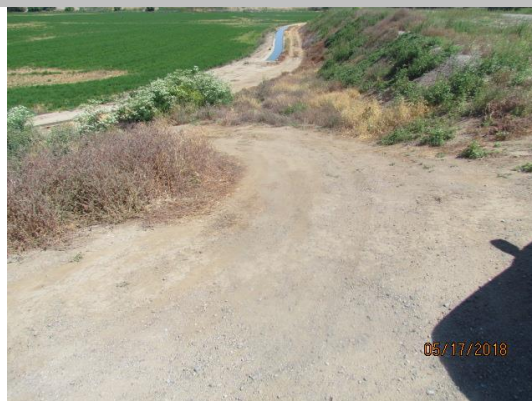
Photo 2 of 2 : FA_2018_RD0001_23_17_20180906_00014.jpg

| Unauthorized ramp on landward slope. | | | | | | |

Looking east at unauthorized ramp on landward slope. (Spring 2018)

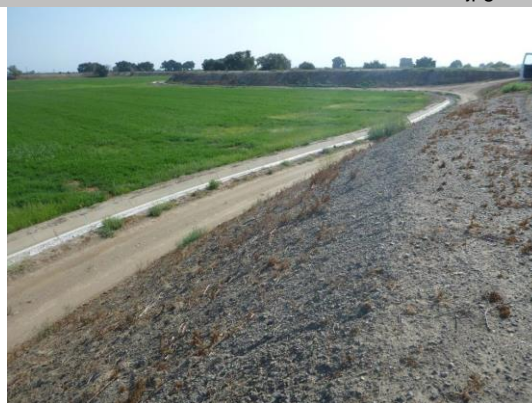
Photo 1 of 3 : LEVAL_FA_2018_496_4367.jpg

| Description:Slope protection repairs are needed along the waterside slope due to erosion and riprap displacement from high water. Based upon levee inspections, it was determined the waterside levee slope is eroding, deteriorating, and degrading. The eroded levee sections need to be restored back to design standards to prevent further deterioration and damage. | | | | | |
| Notes: Start of outside bend. Minor toe erosion has displaced riprap. | | | | | |

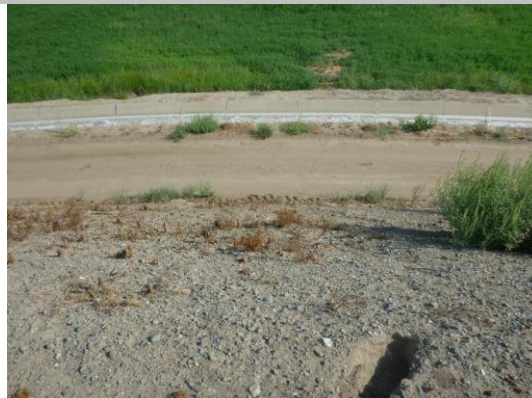
Photo 2 of 3 : LEVAL_FA_2018_496_4371.jpg

| Levee Evaluation Comments Description: Slope protection repairs are needed along the waterside slope due to erosion and riprap displacement from high water. Based upon levee inspections, it was determined the waterside levee slope is eroding, deteriorating, and degrading. The eroded levee sections need to be restored back to design standards to prevent further deterioration and damage. Site ID No: 496 Site Designation: LMA-402 Repair Type: Erosion Rating: Area of Concern Field Date: 8/18/2017 Notes: Start of outside bend. Minor toe erosion has displaced riprap. | | | | | | | | | | |

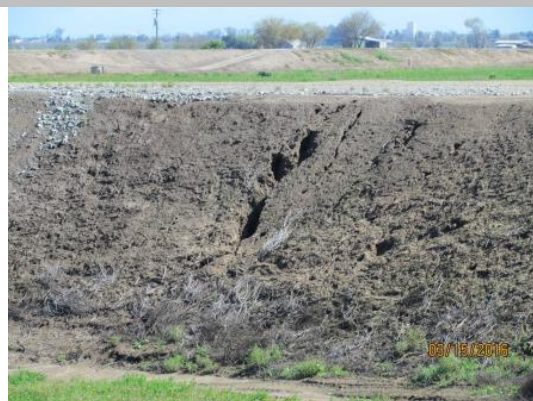
Photo 1 of 1 : FA_2018_RD0001_23_7_20180906_00005.jpg

View of the erosion on the landside levee slope.

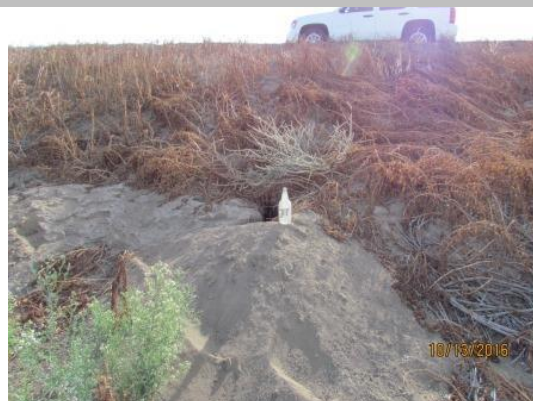
Photo 1 of 1 : FA_2018_RD0001_23_15_20180906_00012.jpg

View of the large rodent burrow in the landside levee slope.

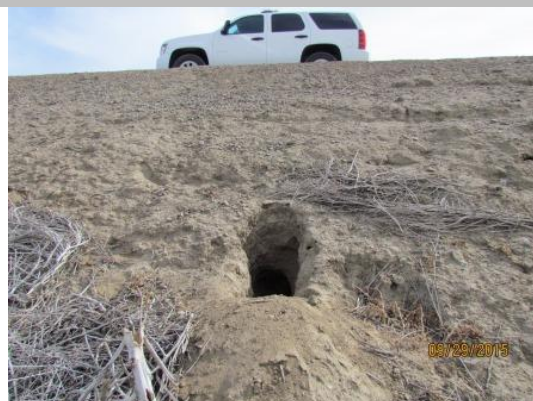
Photo 1 of 1 : FA_2018_RD0001_23_4_20180906_00003.jpg

View of a large rodent hole on the landside levee slope.

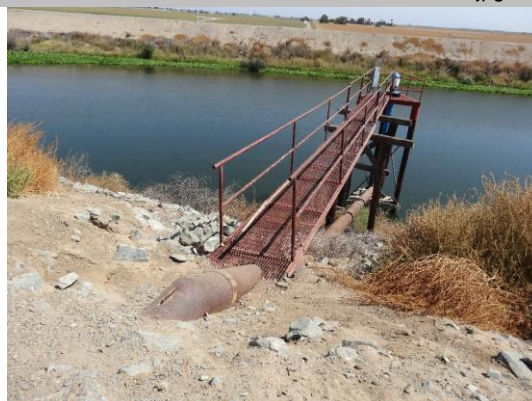
Photo 1 of 3 : UCIP_FA_2018_41600_36004.jpg

| FS_ID:41600 DS_ID:22691 EP_NO: N/A Repair Type: Non-Urgent Crossing Status: Found UCIP Comments: - 2" electric conduit on WS- pipe exposed on both sides.- power pole on LS. - erosion on WS hinge near walkway. FIELD_STRUCT_DESC: 14-inch irrigation discharge pipe of an unknown material and a 2-inch electrical conduit of an unknown material through the levee, 6 feet below the crown. Pump on a pile structure in the stream. Air valve on the landside (LS) shoulder. 30-inch concrete standpipe on the LS toe. [Additional Reference(s): DWR Levee Log, 2005. USACE San Joaquin O&M Manual 8, 1968, (HLM 0.86)]. FS Date: 9/12/2013 | | | | | |

WS view: exposed pipe, walkway, and pump on pile structure. Soil erosion on levee hinge near walkway.

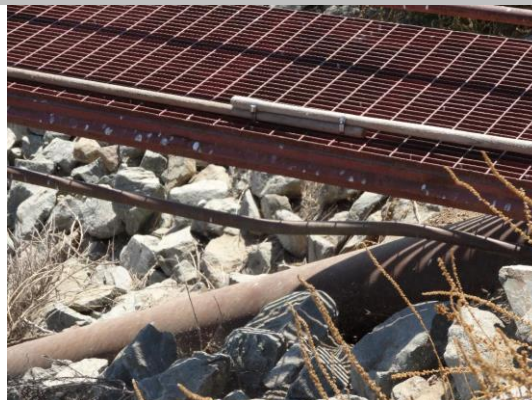
Photo 2 of 3 : UCIP_FA_2018_41600_36003.jpg

WS view: exposed pipe, walkway, and electric conduit under walkway. Rock revetment on lower levee slope.
